ALCORN STATE UNIVERSITY
Lorman, MS

FINAL REPORT

Alcorn State University PC25C Fuel Cell Project

Report on First Year Operations 10/01/00 through 09/31/01

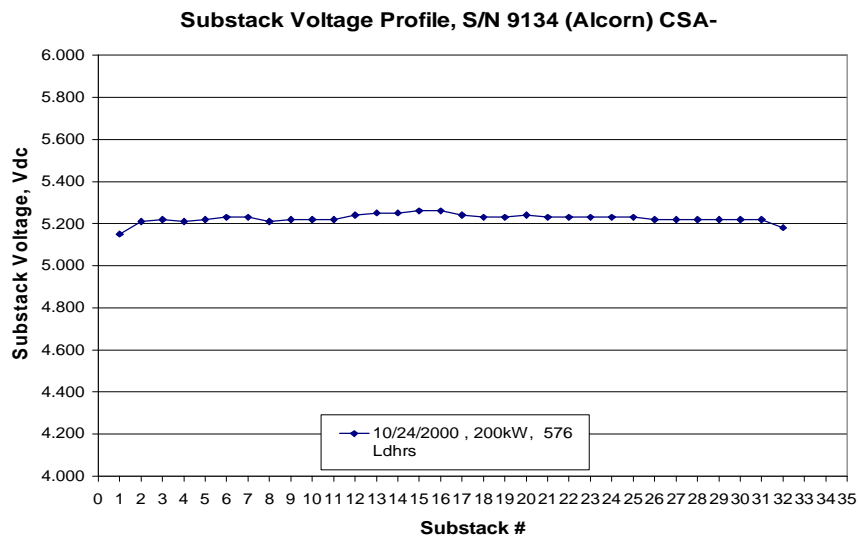
Figure 4, Alcorn Univ. S/N #9134 Initial Substack Profile

10/24/00 Dr. Beke, Alcorn project engineer, reported that the nitrogen system was not holding pressure. A LOGAN engineer was dispatched and found a leak in the exterior nitrogen and enlisted the original contractor to make the repairs. The first substack readings taken after the power plant had accumulated several weeks (550 load hours) run time indicated an average 5.22 VDC from each of the 32 substacks, totaling of 167.2VDC. See Figure 4.

4/27/01 The power plant was restarted, but immediately showed a High TE431 event, so FAN800 was overridden on and VSD830 was overridden to 100%. The power plant was set at 200kW. Substack testing revealed that the average substack voltage had dropped 0.1 volt since the first test.

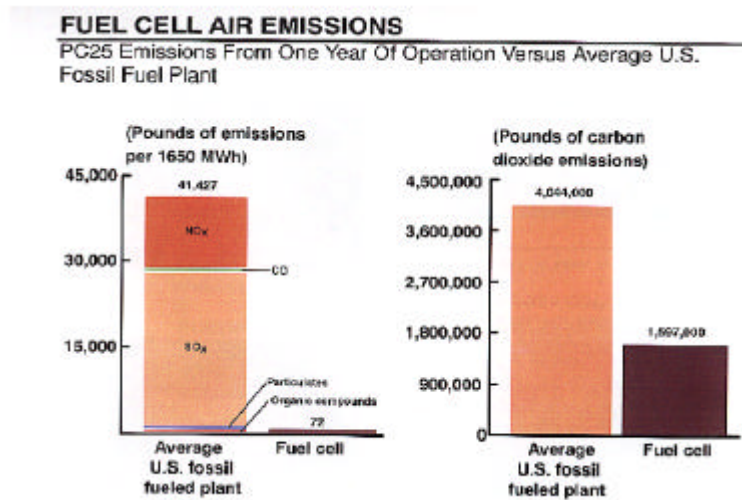
Figure 5

In that regard, the PC25 has an enviable record. One unit operating at 200kW for one year occludes in excess of 40,000 pounds of harmful emissions as compared to an equivalent number of megawatt hours normally associated with oil or coal fired power generation.
